Reconstruction of the collapse of the ‘Azure Window’ natural arch via photogrammetry.

The Azure Window was a natural arch situated in the west coast of Gozo (Maltese Archipelago) that collapsed in March 2017. We employ a Diver Propulsion Vehicle-mounted camera system to capture data for the 3D-modelling of this collapsed arch via photogrammetry. We demonstrate use of this method to document complex underwater geomorphology spread across a large area, and draw up a geomorphic assessment of the site and collapse event on the basis of this 3D-model. The methodology enables a reconstruction and understanding of the collapse event. On account of the high-resolution attained, we are able to cross-match the principal submerged components with their pre-collapse location; this enables an understanding of the dynamics of the collapse, confirmation of rock break-up along existing joints, and mapping the distribution of the rock and debris from the collapse event. We conclude that the key stages in the collapse of the Azure Window entailed erosion at the base of the pillar, leading to the latter’s collapse in the southwest direction, breaking into two main sections that separated along the l

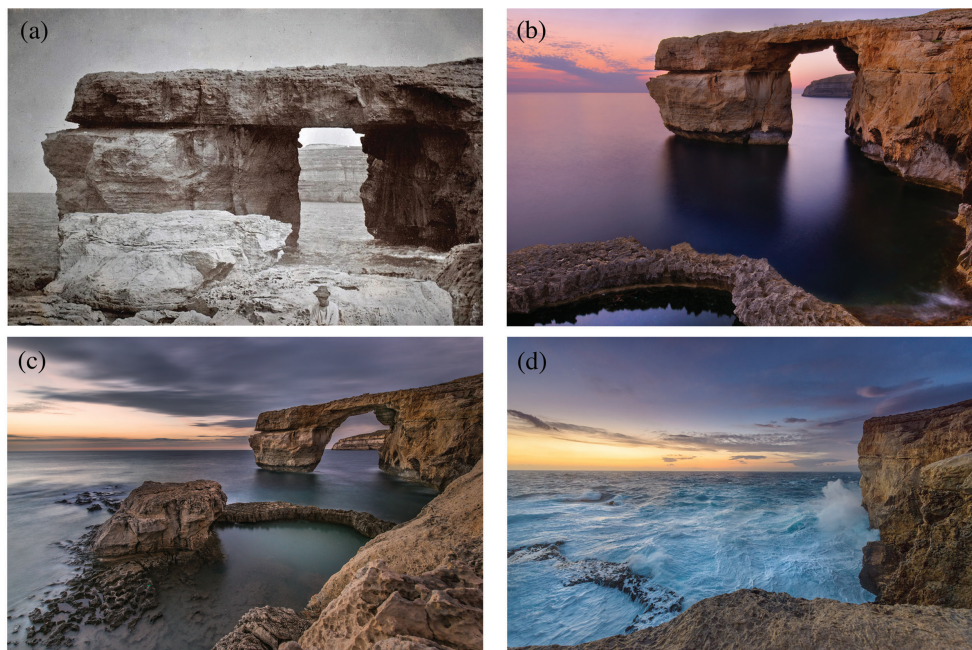
Figure 3: This sequence of images shows the deterioration of the arch leading up to its collapse. Panel (a) is a photograph by Richard Ellis from *c.* 1900, in which the arch exhibits a rectangular shape (practically identical to that visible in the 1981 film ‘Clash of the Titans’). Panel (b) is an April 2011 photograph that shows substantial thinning of the arch’s ceiling. Also visible is a long crack in the pillar that had developed by this time. Panel (c) is an October 2012 photograph in which one can observe a wider arch due to the collapse of a large segment of the pillar, which detached along the crack visible in panel (b). Panel (d) is a photograph of the site on the evening of the arch’s collapse on the 8th of March, 2017. Although the weather conditions were worse at the time of collapse, significant wave action can still be seen. Photo (a) is being used with the permission of Giovanni Bonello. Photos (b)-(d) are copyrighted by J. Caruana.

to its demise. From a very rectangular form (Fig. 3a) it progressed to an arched aspect due to bridge-thinning (Fig. 3b), losing a significant segment from the pillar in 2012 (Fig. 3c), and collapsing 5 years later (Fig. 3d).

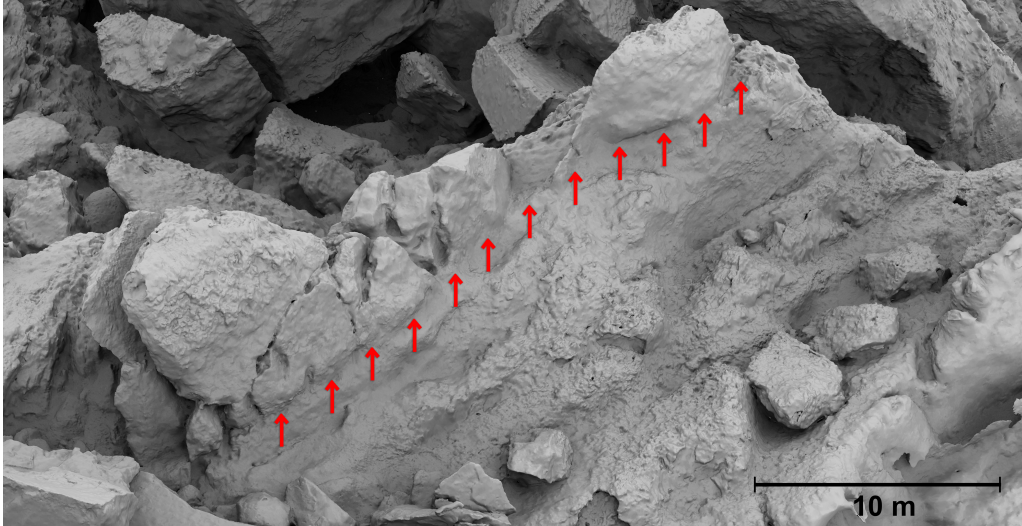
Figure 9: An ortho-image of Component 1, derived from the model using the software Metashape and Cloud Compare. The image shows the view when looking towards the southwest, exhibiting the northern face of the ridge (running diagonally from lower left to upper right of this image). The ridge, which tapers upwards towards the surface, exhibits a regular notch at a depth of $\approx 8\text{-}9\text{m}$ (marked with arrows) and several cracks and steps.

The cause of the collapse of the pillar section is likely erosion at its base. The tapered ridge as well as a notch that was formed at the base of the pillar (Fig. 9) clearly point to progressive loss of support. (See Fig. 13 for side-views of the pre-collapse Azure Window and the post-collapse base of the pillar.) The end-result was that no stack remained above the waterline. The collapse was precipitated by the violent storm that battered the site at the time, with numerical models of meteo-marine fields yielding wave-heights of up to around 3 m and wind-speeds larger than 16 ms^{-1} (see Fig. 5 in Galea et al., 2018), in agreement with wind records that show wind gusts reached $\approx 18\text{-}20 \text{ ms}^{-1}$ before the collapse.
