Echo Sounders versus Air Bubbles in Research Vessels

Within echo sounding circles it is well known that air bubbles may have a negative effect on echo sounding systems. This article briefly presents the German way of dealing with air bubbles from sweep-down and cavitation processes as well as our experiences with the last three large research vessels (RVs *Polarstern*, *Meteor* and *Maria S. Merian*). The practical experience resulted in the development of an optimised new hull form for the replacement of RV *Sonne*. The new ship is now under construction at a German shipyard and will be delivered in autumn 2014.

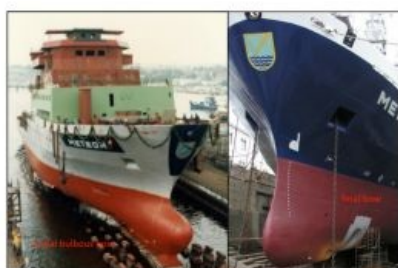
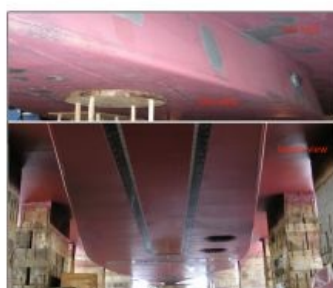
In general, any given problem has several and sometimes quite different solutions. These differences may reach into the field of philosophy. Why should it be different when dealing with the problem of ‘echo sounders versus air bubbles’? The philosophy in Germany concerning the installation of echo sounding transducers is to keep them as close to the bottom as possible. Thus, the optimal solution would be a flat hull and a flush installation. Actually, in most German research vessels echo sounding transducers are installed as far as possible to the front and within a box keel (height between 50 and 70cm) enlargement.
