# **POS – 405**

## **RV POSEIDON**

# **Cruise Report**

**07<sup>th</sup> December 2010 – 22<sup>nd</sup> December 2010**

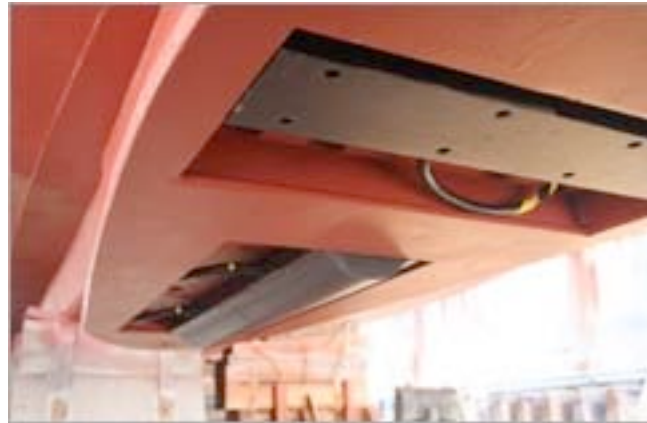
*Gondola with Multibeam transducers*

The SeaBeam SBE 3050 multibeam system by ELAC Nautik was recently built into the hull of RV POSEIDON. For this purpose a gondola was fixed underneath the hull of POSEIDON, which gave space for the transducers and provides best protection against bubble disturbances. Due to size limitations the transducer arrays were chosen in a 1.5° by 2° dimension. The SeaBeam 3050 is the latest generation of mid and shallow water multibeam bathymetric sonar systems from L-3 Communications ELAC Nautik GmbH. The new multi-ping technology of the SeaBeam 3050 allows a higher maximum survey speed without losing 100% bottom coverage by creating two swaths per ping cycle. The system operates in the 50 kHz frequency band in water depths ranging from 3 m below the transducers to approx. 3,000 m.

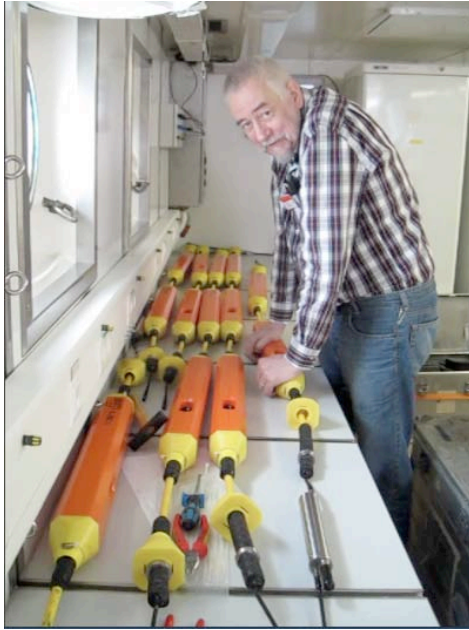
Figure 5b.2: Photograph of the streamer hydrophones and cable segments during setup of the multichannel chain.

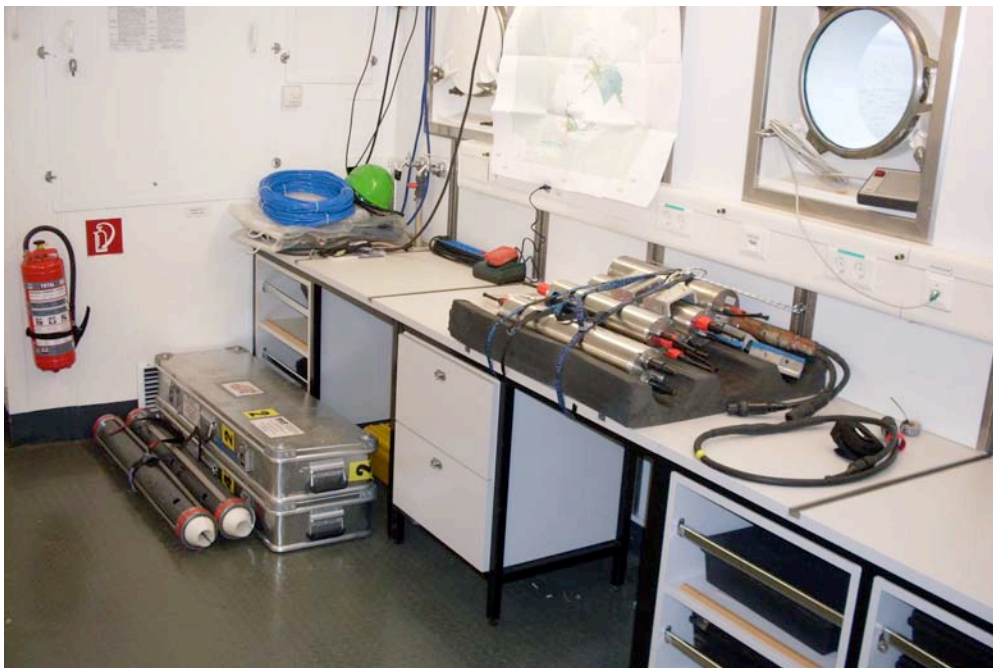
*Figure 5c.4 Receiver Units and frames (floor) in the lab.*

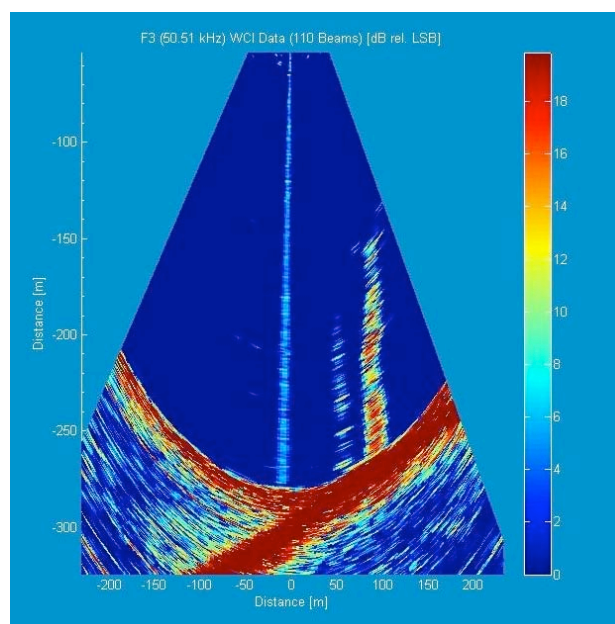
Figure 6a.4: Gas flares rising from the seafloor, imaged online by the WCI-viewer

A second survey, dedicated to image and map gas flares, was conducted at the shelf break. Here the survey area was targeted at the flanks of the Danube Canyon (Fig. 6a.4), roughly 5 km west of the first survey area. An additional calibration was applied first to correct for possible inaccurate roll, pitch and yaw angles. Unfortunately, mapping of the Danube Canyon had to be interrupted again due to bad weather, but could be continued 12 hours later with success. On a track starting from the northern flank of the canyon, across the valley and following the southern flank of the canyon, numerous gas flares of different shapes were visible on the online WCI-viewer (Fig. 6a.5). This example shows the great advantage of multibeam techniques in flare imaging, because swath systems are able to detect flares offline to the centre beam. A single-beam system would have missed the flare, shown in Figure 6a.5. A newly developed post-processing sequence of a wider range of WCI-data was tested earlier and already found this specific area promising for possible flare bursts.

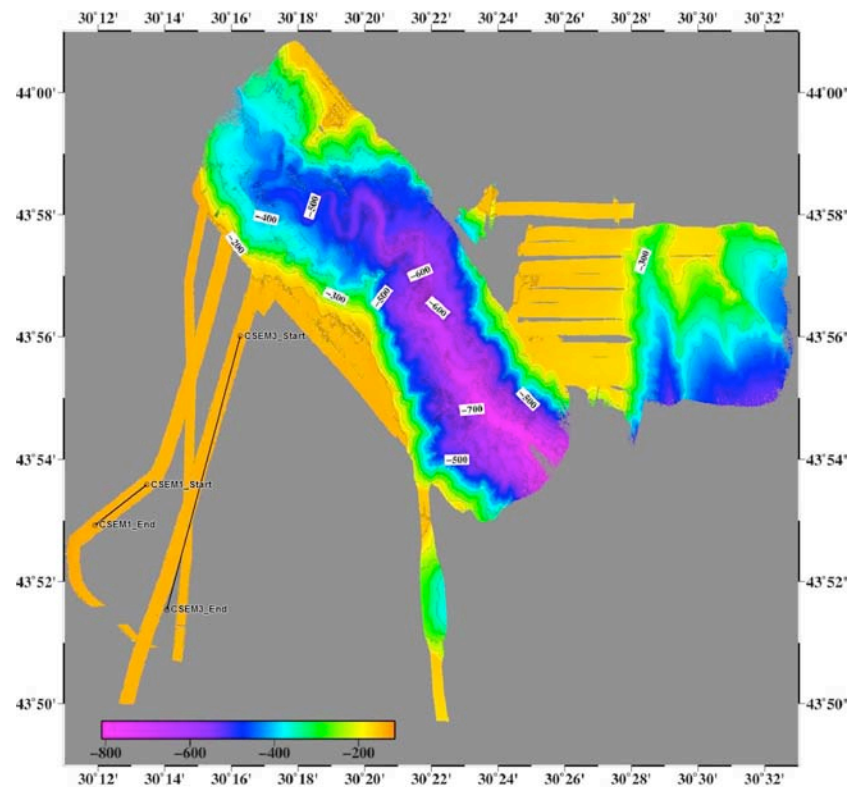
Figure 6c.2: Bathymetry map of the survey area with CSEM profiles 1 and 3.

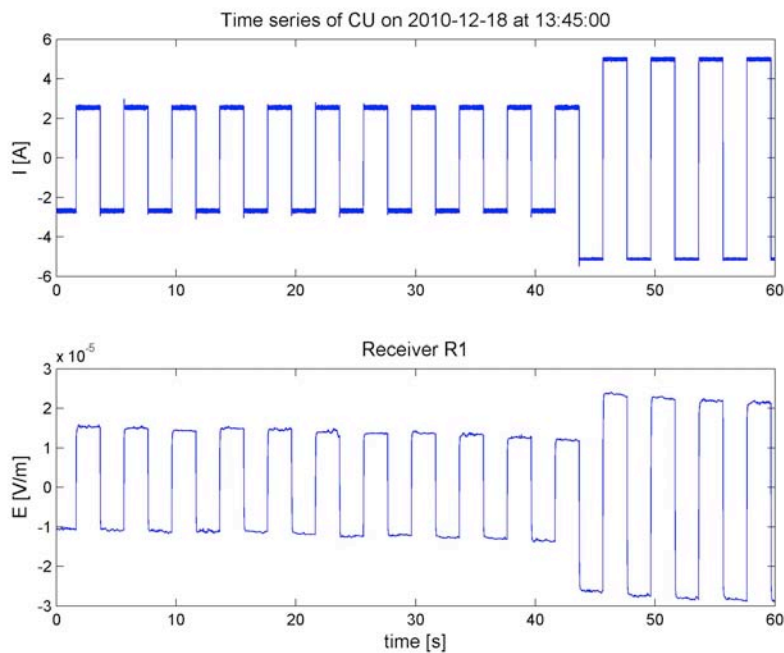
Figure 6c.3: Time series example of the first deployment with Receiver 1. The amplitude was increased within this one minute time window. The data which are recorded at 10 kHz have been averaged and decimated to 1250 Hz.

Due to weather conditions and a short time slot only one receiver was used and the deployment was performed in shallow water for a quick recovery in case of sudden weather changes. Different signal forms and amplitudes were applied. The transmitter was unintentionally shutting down at signal amplitudes greater than 8A because the resistance of the tow cable was too low. The load (a heater with 8 sauna heating elements) which is used to run the transmitter in the laboratory was put in series between the transmitter and the tow cable and the transmitter was able to output amplitudes up to 13A.

The transmitted signal which is also displayed and recorded in the lab during the deployment is prone to the unstable electricity supply of the ship. Different grounding tests of the signal driver box showed best results when the signal driver box was grounded to the housing of the transmitter.

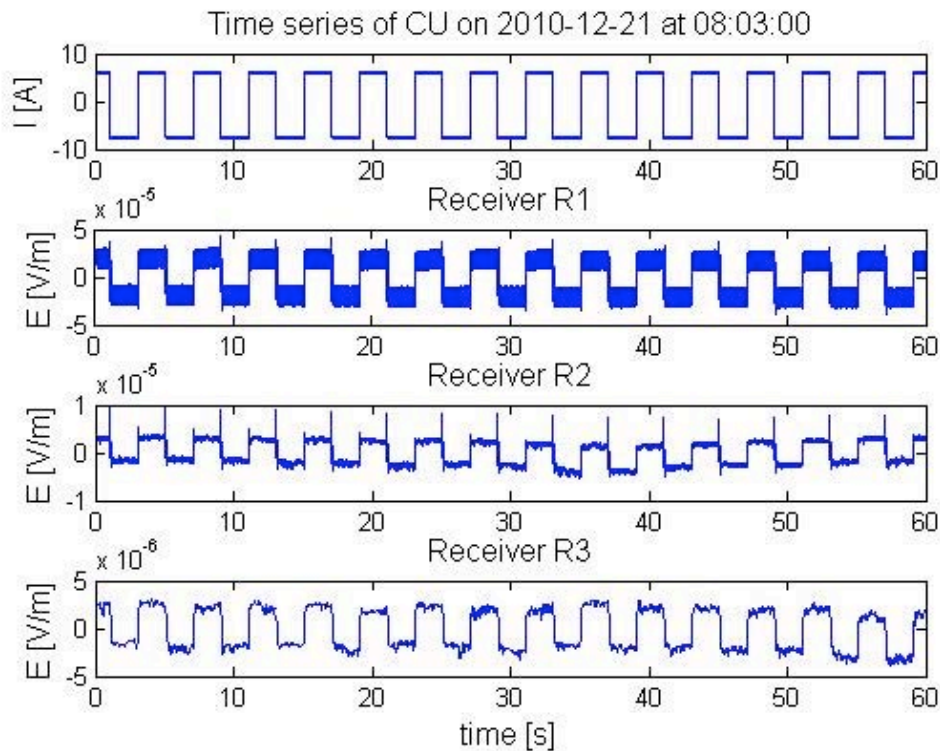
Figure 6c.5: Time Series example of the third deployment with 3 Receiver Units while moving. Due to the wire connection modification, data quality improved significantly: spikes at polarity changes decreased and all receiver data are useful even when moving the system.

The last deployment was carried out in shallow water with three receiver units (RU1, RU2, RU3). Data have been recorded with all units. Different wave forms and signal amplitudes were applied. Data were collected in stop and go modus. A first inspection of the data showed the noise level was reduced by moving digital ground to an inner conductor. During deployment 2 data quality of the last receivers was only sufficient while stationary on site – now all receiver data are useful even when moving.
