Reconstruction of the collapse of the ‘Azure Window’ natural arch via photogrammetry.

The Azure Window was a natural arch situated in the west coast of Gozo (Maltese Archipelago) that collapsed in March 2017. We employ a Diver Propulsion Vehicle-mounted camera system to capture data for the 3D-modelling of this collapsed arch via photogrammetry. We demonstrate use of this method to document complex underwater geomorphology spread across a large area, and draw up a geomorphic assessment of the site and collapse event on the basis of this 3D-model. The methodology enables a reconstruction and understanding of the collapse event. On account of the high-resolution attained, we are able to cross-match the principal submerged components with their pre-collapse location; this enables an understanding of the dynamics of the collapse, confirmation of rock break-up along existing joints, and mapping the distribution of the rock and debris from the collapse event. We conclude that the key stages in the collapse of the Azure Window entailed erosion at the base of the pillar, leading to the latter’s collapse in the southwest direction, breaking into two main sections that separated along the l

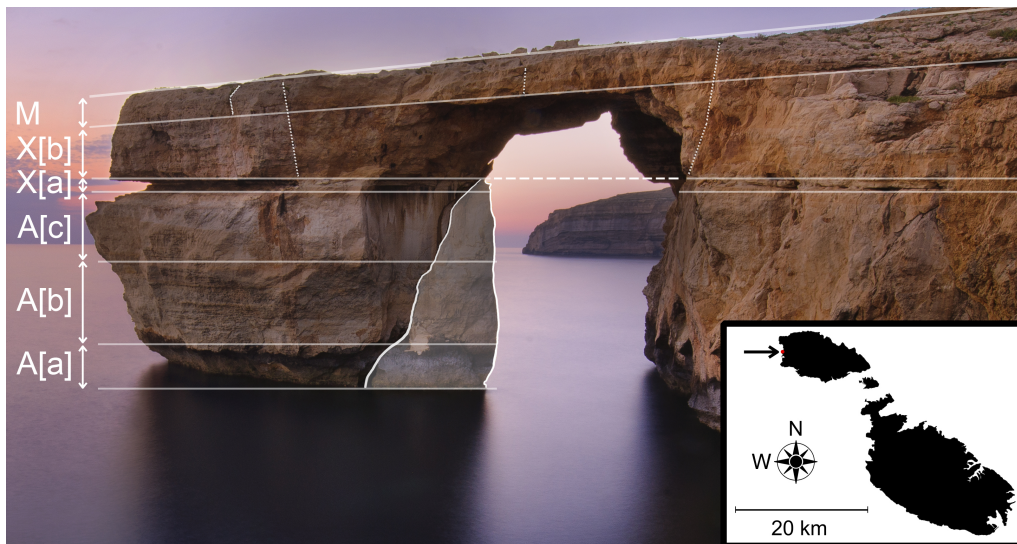
Figure 2: Lithology of the Azure Window, after Pedley (1978). Labels 'A', 'X', and 'M' denote Attard, Xlendi and Mara members respectively. Letters in square brackets denote principal subdivisions of facies. Dotted lines denote visible cracks on the Xlendi and Mara members. The horizontal, dotted line underneath the bridge marks the boundary above which rockfall (largely from the X[b] member) took place since a c. 1900 photo by Richard Ellis (Panel (a) of Fig. 3). The shaded region on the pillar marks a large section that collapsed in 2012. The inset shows a map of the Maltese Islands with the location of the former Azure Window (west coast of Gozo), marked with an arrow. The site coordinates are $36^{\circ}03'12.9''\text{N}$, $14^{\circ}11'19.1''\text{E}$. (Image copyright: J. Caruana.)

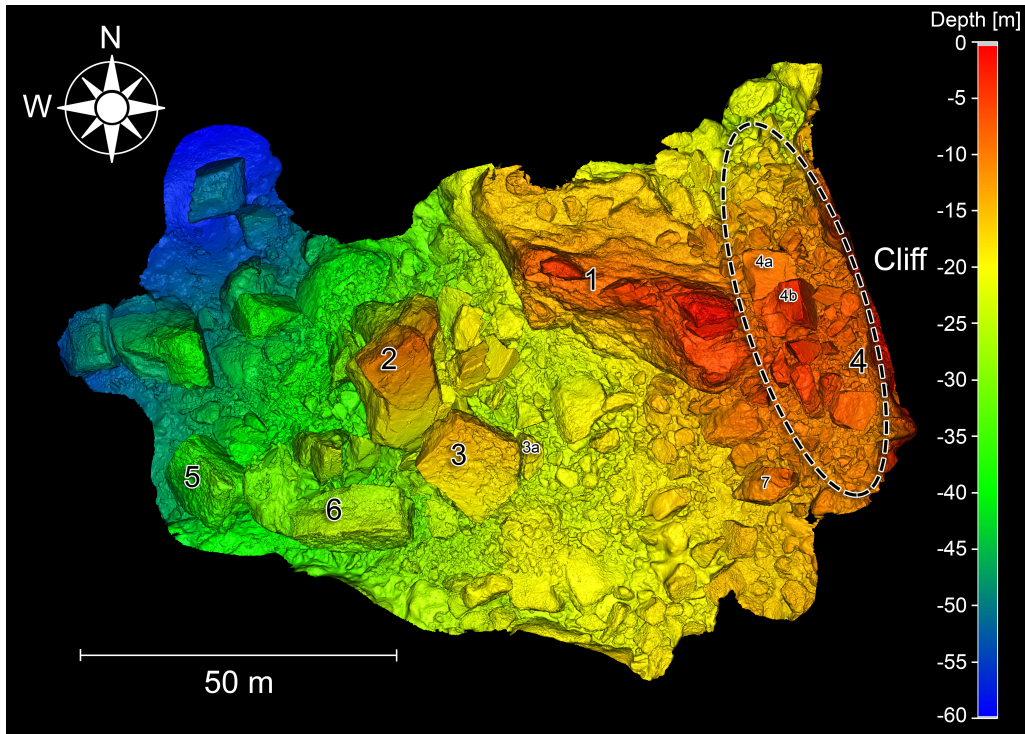
Figure 8: Depth-map of the site of the former Azure Window generated with the software Cloud Compare. Identified remains are scattered across a wide range of depths, from ≈ 3 m below the surface down to ≈ 60 m. The seabed slopes from shallow waters in the east to deeper waters in the west.

From Fig. 8 one may appreciate how the seabed exhibits a slope from shallow waters in the east (beneath the cliff) to deeper waters in the west.
